## ***The Pursuit Of Images Of Columbia***

### **Launch: Impact—"No Apparent Effect..."**

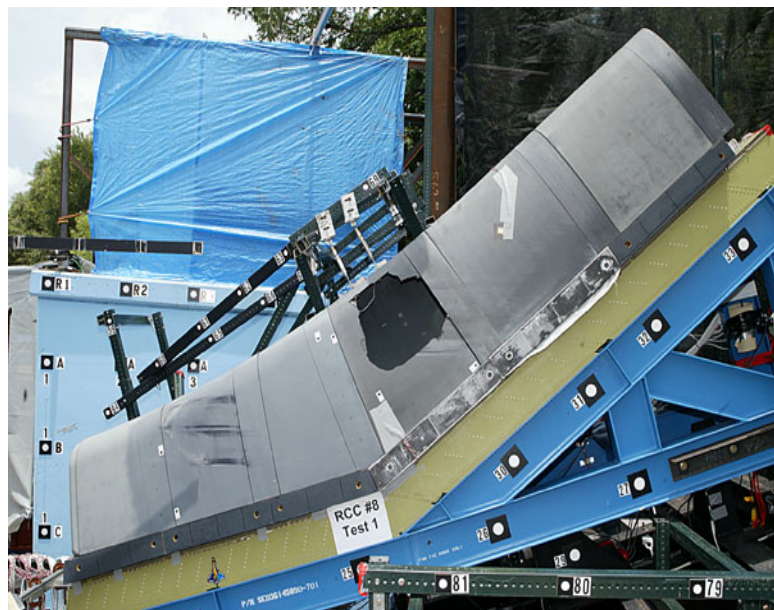
Figure 2: Results from the Foam-Impact Test of the Columbia Debris Strike. Source: NASA Image.

In the aftermath of the accident, heroic efforts were made to recover all possible pieces of debris and to fully understand the cause of the accident. The *Columbia* Accident Investigation Board tested the impact of foam on various areas of the wing and proved what had been thought unthinkable: foam could indeed compromise the thermal protective system. Tests revealed a gaping hole in the RCC panel of the Orbiter wing when hit by foam at the relevant speed. The Board concluded, “the physical cause of the loss of *Columbia* and its crew was a breach in the thermal protection system on the leading edge of the left wing, caused by a piece of insulating foam, which separated from the left bipod ramp section of the external tank at 81.7 seconds after launch, and struck the wing in the vicinity of the lower half of reinforced-carbon carbon panel number 8.”<sup>7</sup>
