Analysis of a Fatal Wind-Driven Fire in a Single-Story House

BY ADAM BAROWY
AND DANIEL MADRZYKOWSKI

On April 12, 2009, a fire in a one-story ranch home in Texas claimed the lives of two firefighters. Sustained high winds occurred during the incident. The winds caused a rapid change in the dynamics of the fire after the failure of a large section of glass in the rear of the house. At the request of the National Institute for Occupational Safety and Health (NIOSH) and the Houston Fire Department (HFD), NIST assisted with examining the fire dynamics of this incident. NIST performed computer simulations of the fire using NIST's FDS computer model and Smokeview, a visualization tool, to provide insight on the fire development and thermal conditions that may have existed in the residence during the fire. For the full details of the study, see the original report "Simulation of the Dynamics of a Wind-Driven Fire in a Ranch-Style House—Texas."⁸

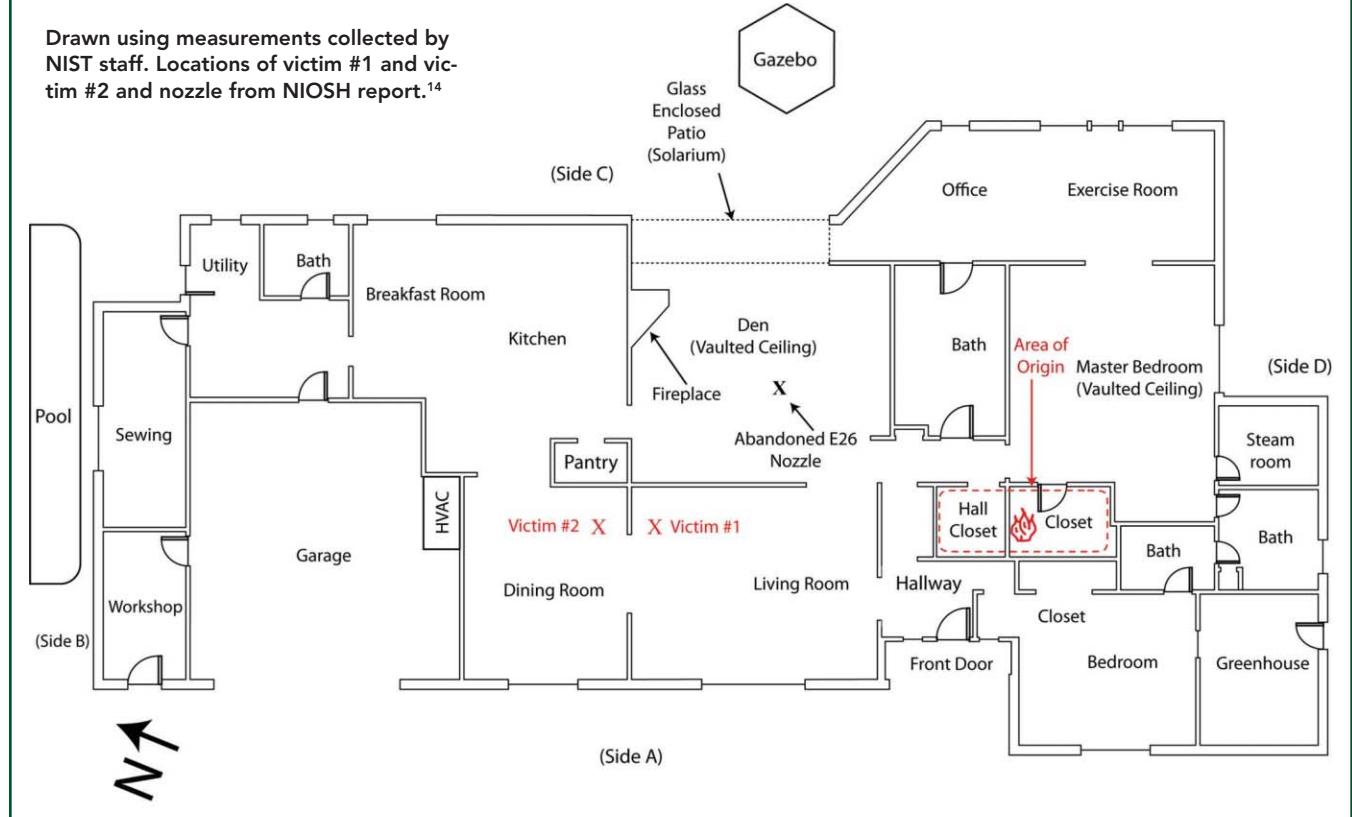
Figure 1. Plan View of Residence

According to the Texas state fire marshal’s investigation, the fire was ignited by overheated wiring in the ceiling light fixture in a closet. Figure 1 shows a plan view of the structure with the location of the area of fire origin marked, as well as the locations where each firefighter was found. It is unknown how long the fire had been burning before being detected by the occupants. While preparing for bed, an occupant in the master bedroom observed a flickering light coming from the closet. Upon inspection, flames and smoke were visible from “eye level to ceiling level inside the closet.” (13) As the occupants exited, the interior and exterior overhead garage doors were left open.

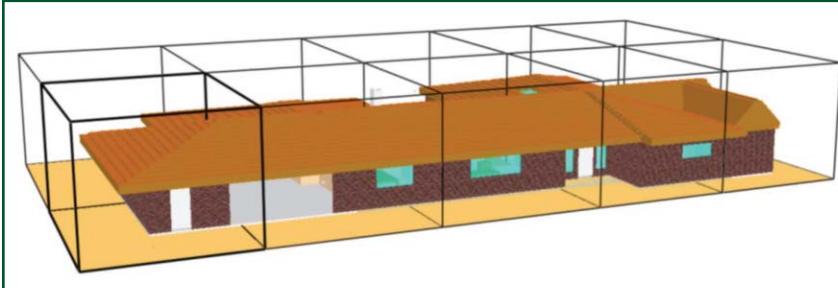
Figure 2. Computational Domain of the Simulation

The floor plan of the one-story ranch-style house involved in this incident is shown in Figure 1. Based on the NIOSH (13) and Texas state fire marshal (14) reports, the original structure was built in 1956. The structure measured approximately 108 feet long by 48 feet wide. The structure consisted of traditional stick-built wood construction with a brick veneer over the exterior walls. The interior finish of the structure was gypsum board walls and ceilings. Figure 2 shows a view of the structure as modeled in FDS.

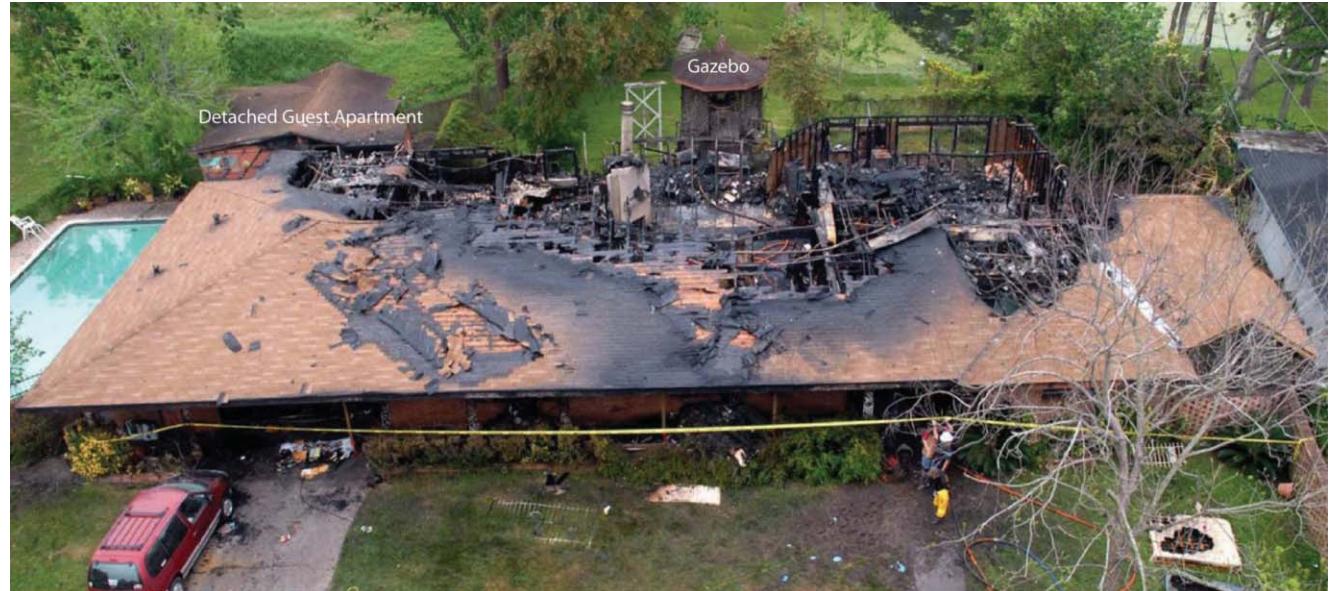
Figure 3. Aerial View of Damage to the Structure

Permit records indicate multiple modifications to the property. Portions of the roof were constructed over the original roof, which added to the combustible load in the attic, as well as created void spaces for pyrolyzed fuel to collect. The specific details of all the modifications are not known because of the extensive damage of the structure. Figure 3 shows an aerial view of the fire damage to the structure.

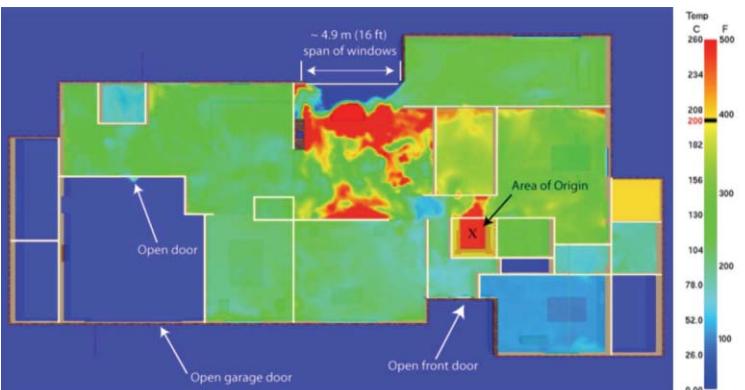
Figure 4. Nonwind-Driven Simulation

Figure 4 shows the temperatures at five feet above the floor (the approximate height of the face piece of a standing firefighter) for the nonwind-driven fire simulation, 10 s after

Simulated temperatures at five feet above the floor throughout the house 10 s after solarium failure. Overhead view of floor plan.

the solarium windows failed. From the fire in the den, most of the heat exhausted from the opening in the solarium or into the attic space through the hole in the den ceiling. Some of the heat and smoke flowed out of the upper portion of the open front door. In this case, the front doorway serves two functions: The lower portion of the doorway is an inlet opening for fresh air, and the upper portion of the doorway is the exhaust for a portion of the fire gases.

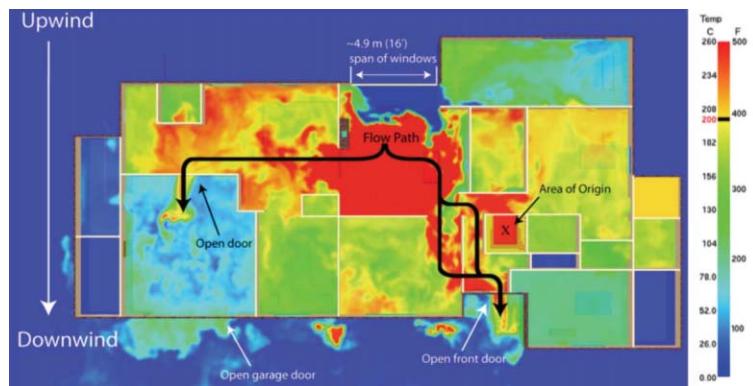
Figure 5. Wind-Driven Simulation

Temperatures at five feet above the floor throughout the house 10 s after solarium failure. Overhead view of floor plan.

Figure 5 shows the temperatures at the same elevation for the wind-driven fire simulation 10 s after the solarium windows failed. The main inlet opening for the flow path is now the solarium windows on the upwind side of the house. Fresh air, driven through the failed solarium panels, interacts with the body of the fire in the den and the attic. The flow path splits, with exhaust into the attic space as before. In addition, the wind forces fire gases through the house to the exhaust openings at the front doorway and the garage doorway. This change in conditions caused by the wind may explain the "whooshing" sounds and increasing temperatures experienced by E-36 and the conditions that disoriented and overwhelmed the E-26 crew.

The results of the “no-wind” and “wind” fire simulations demonstrate how wind conditions can rapidly change the thermal environment from tenable to untenable for firefighters working in a single-story residential structure fire. These results are in agreement with NIST studies conducted to examine wind-driven fire conditions in high-rise structures. This emphasizes the importance of including wind conditions in the scene size-up before beginning and while performing firefighting operations and adjusting tactics based on the wind conditions. It is critical for firefighters to stay clear of the exhaust portion of the fire flow path.

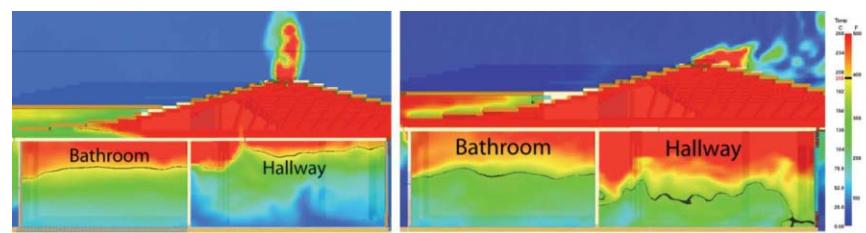
Figure 6. Hallway Temperatures

Comparison of nonwind (left) and wind (right) simulations in the hallway area, 10 s after the failure of the solarium glass.

the wind-driven case compared to the nonwind-driven case. In the nonwind-driven case, the higher heat conditions [greater than 100°C (212°F)] in the gas layer only exhaust out of the top quarter of the doorway opening. In the wind-driven case, the high heat condition exists from the ceiling down to the floor of the hallway, and hot gases flow out of the front door, top to bottom. Cool air no longer flows into the front doorway. After the failure of the solarium glass, the high pressure from the wind pushed fire gases through the structure from the rear to the front. The front doorway became an exhaust vent, as did the garage door.

Figure 6 shows the increased simulated temperatures in the hallway 10 s after the failure of the solarium windows in

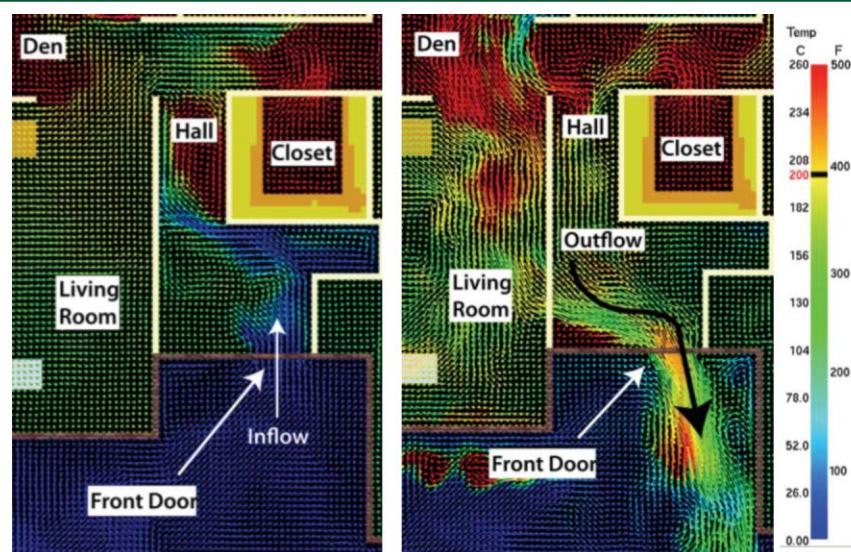
Figure 7. Front-Door Air Flow

Figure 7 presents visualizations of the direction of gas flow at the five-foot position above the floor in the front doorway and the front hall, looking down at a plan view of the structure. On the left, Figure 7 shows the thermal conditions 10 s before the failure of the solarium glass (no wind effect). At this time, cool air is being drawn into the structure through the front doorway. After the solarium glass failed, the wind caused a flow reversal at the front doorway. The wind entering the structure through the broken solarium glass increased the pressure at the rear of the structure and forced the fire gases through the den into the front hall and out the front door. The same was true for the flow through the kitchen and out

Flow into front door 10 s before (left) and 10 s after (right) the failure of solarium glass at a plane five feet above the floor. Overhead view of floor plan.
